**Physical verification report of the project namely  
"CONSTRUCTION OF GOLF COURSE CLUB BUILDING"  
District Jammu**

**Name of Project:** Construction of 18-holes Golf course and Club Building on bank of R Tawi at Sidhra Jammu

**Implementing Agency:** Tourism & Culture Department

**Executing Agency:** Maintenance & Works Wing of Directorate of Tourism, Jammu

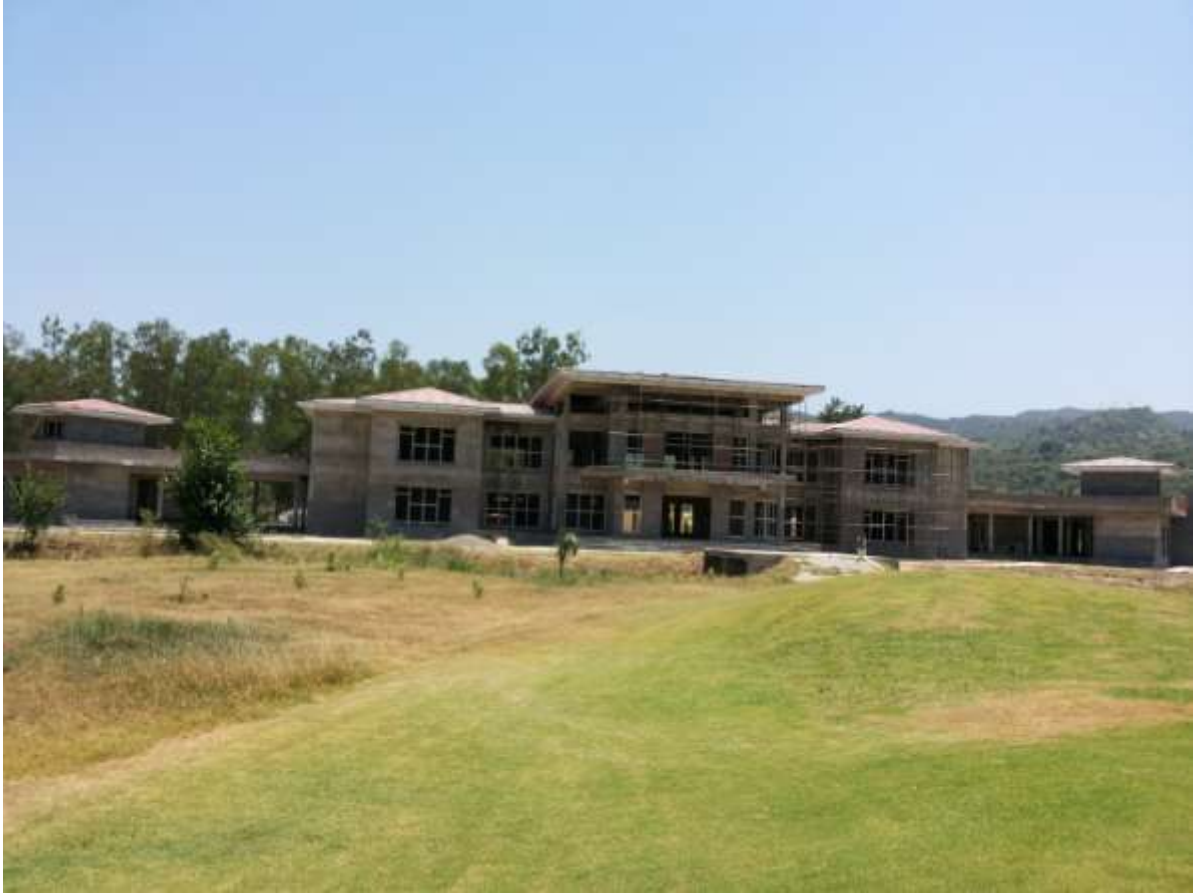
The construction work of the club house building taken up a couple of years back is about 60% complete. The structure of club house comprising a double storey building in the centre and two adjoining single storey buildings with connecting corridors to the central building is almost ready. The finishing work, such as, electrical fitting, sanitary fitting, AC fitting, laying of false ceiling is in progress. The quality of construction work as well as construction material used, such as, glazed marble, vitrified tiles, ceramic tiles, aluminium door/ window frames is good. The attic floor of the two buildings adjacent to the main building of club house shall be used as restaurant and bar and are being developed accordingly. However, the roof of the first floor of the main building comprises of steel truss structure with steel sheets laid over and slanting on all sides. Such roofs are preferred in Kashmir valley which witness's snowfall during winter months. Had flat reinforced concrete roof been laid over the first floor of the main building its attic could also have been utilized without making much difference in the cost of construction of the club building. The contractor who has been allotted the construction work of the club building informed that he has no option but to stop the work in case liabilities are not cleared in the next few months.

**View of Club Building from Golf Course**

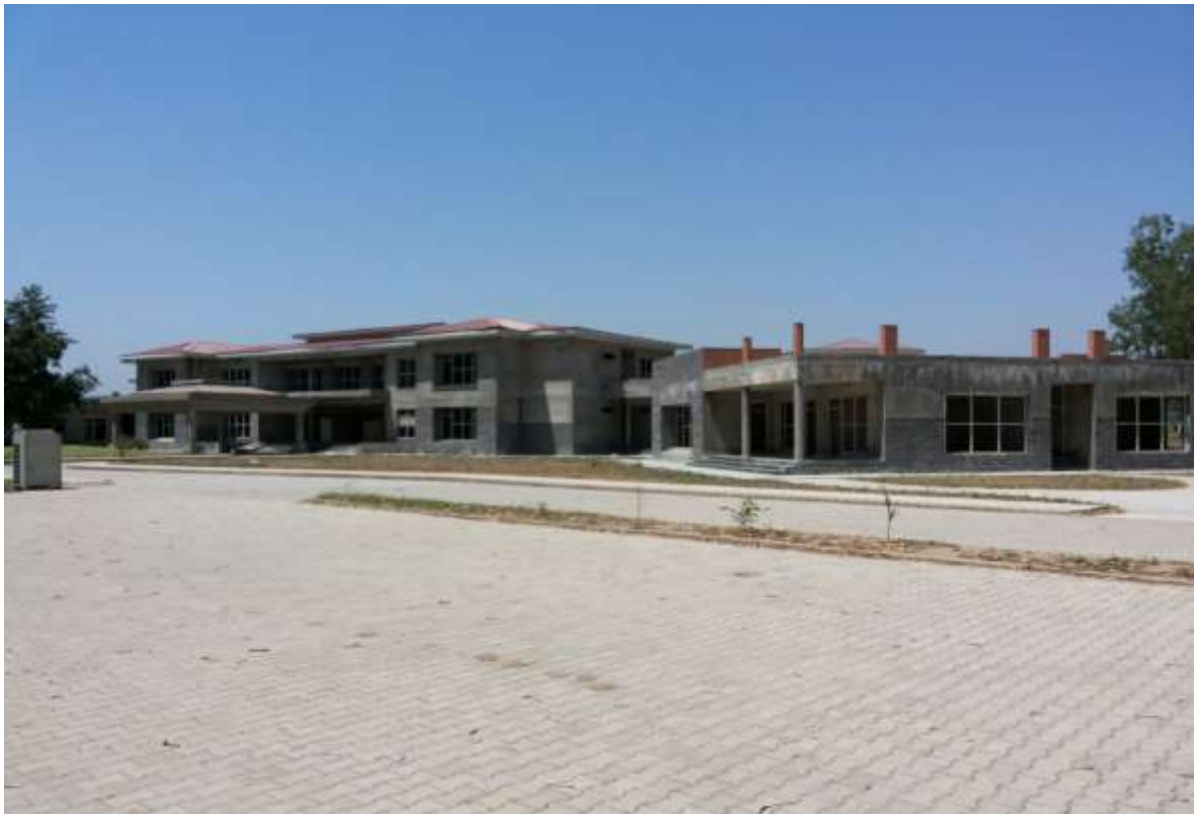
**Entry point of Club Building**

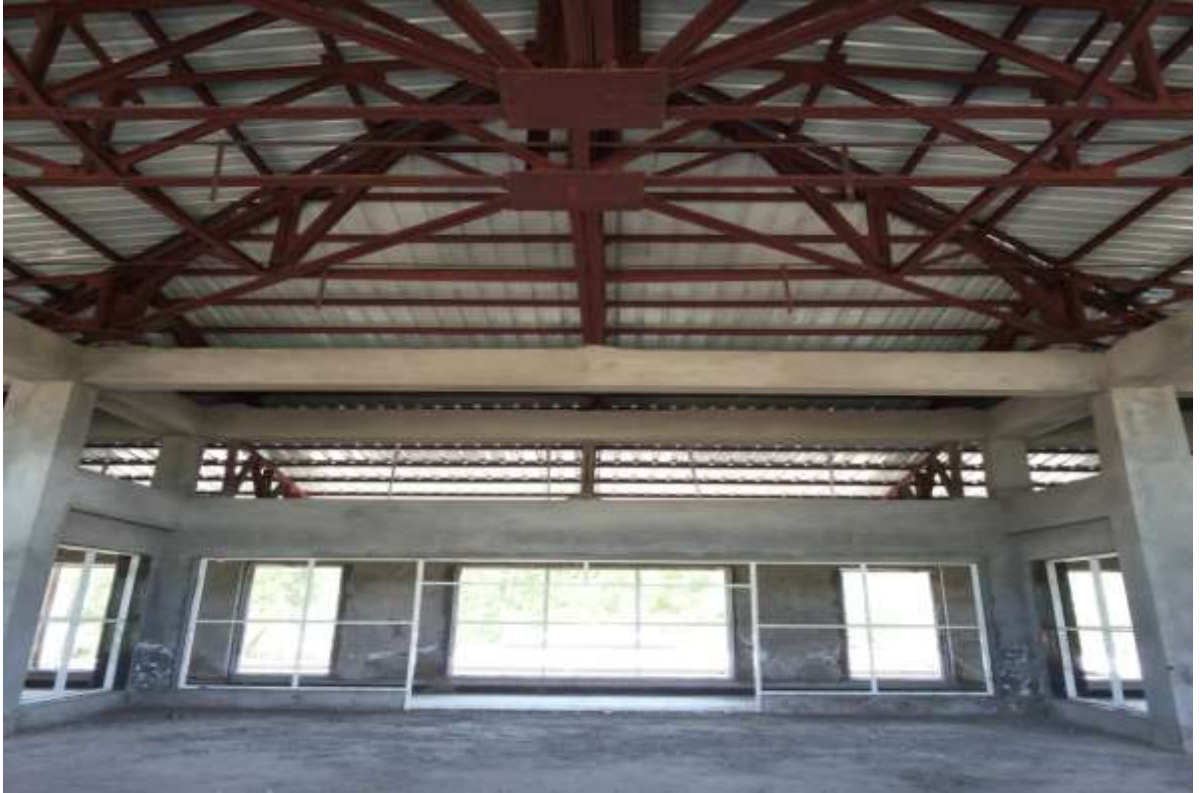
**Steel Truss being laid over 1<sup>st</sup> floor of Club Building**

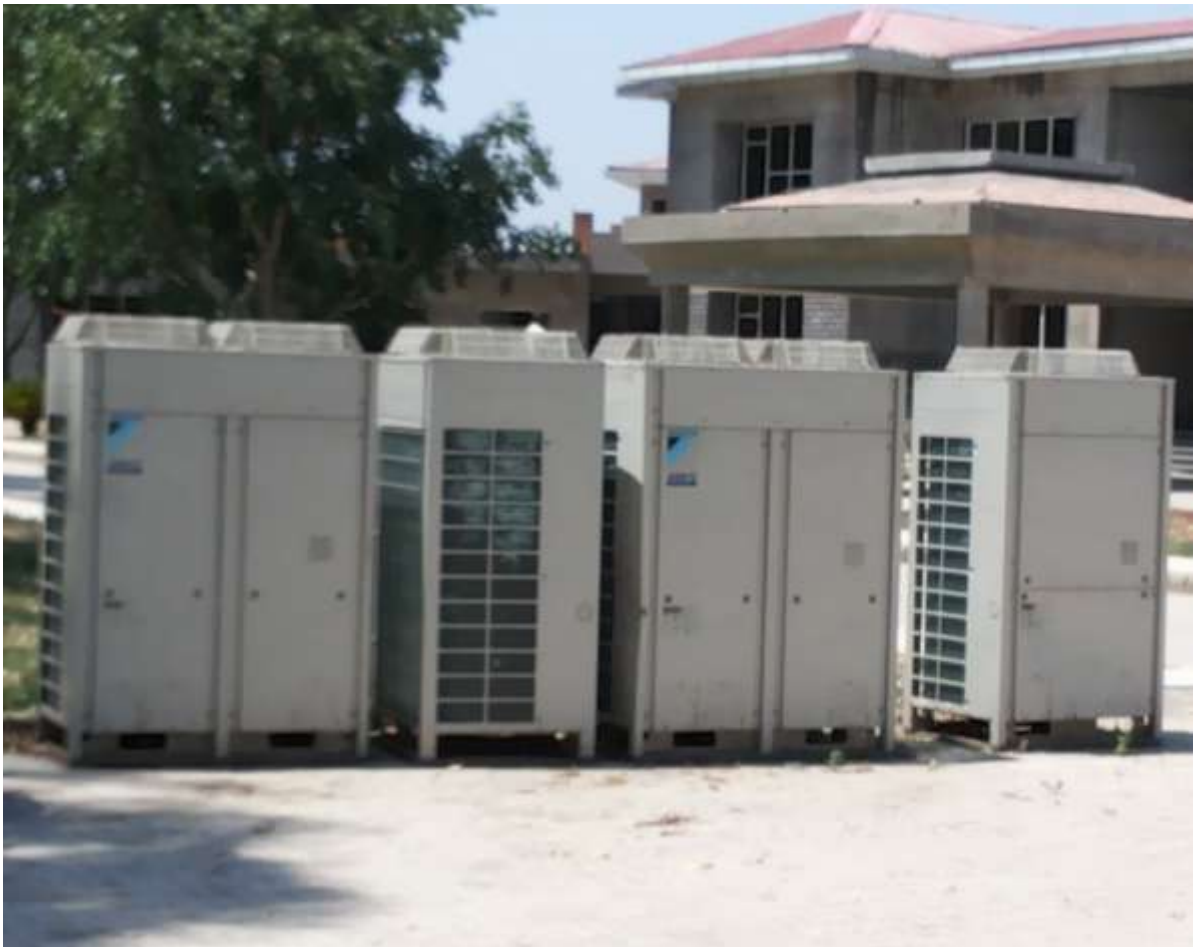
**AC equipment placed at site**

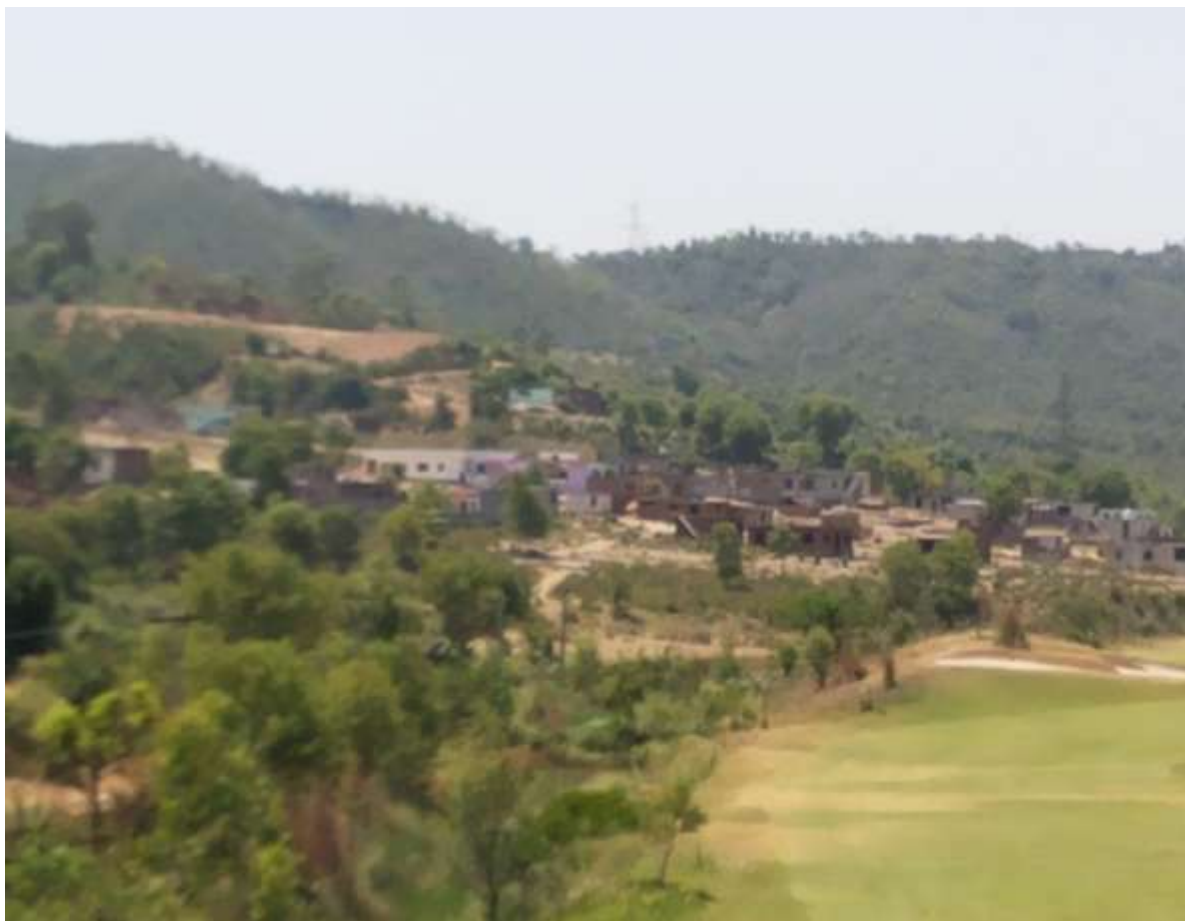
- 4) **Encroachment of land adjacent to Golf Course, Sidhra:-** A large number of dwellings have come up on the land adjacent to the Golf Course. The State Revenue Department and Jammu Development Authority needs to depute a team of officials to verify the same and take appropriate steps to remove all illegal encroachments/ structures before people start residing there.

**Encroachment on the land adjacent to Golf Course**
